**National Highway
Traffic Safety
Administration**

Case Vehicle (A): 2000 Volkswagen
 Type: Jetta GLS, 4-door sedan
 Driver: 21-year-old female
 CDC: 01-FYEW-1

Vehicle (B): 1999 Chevrolet
 Type: C1500 pickup, 4x2 2-door
 Driver: 48-year-old male
 CDC: 99-0000-0

SITUATION

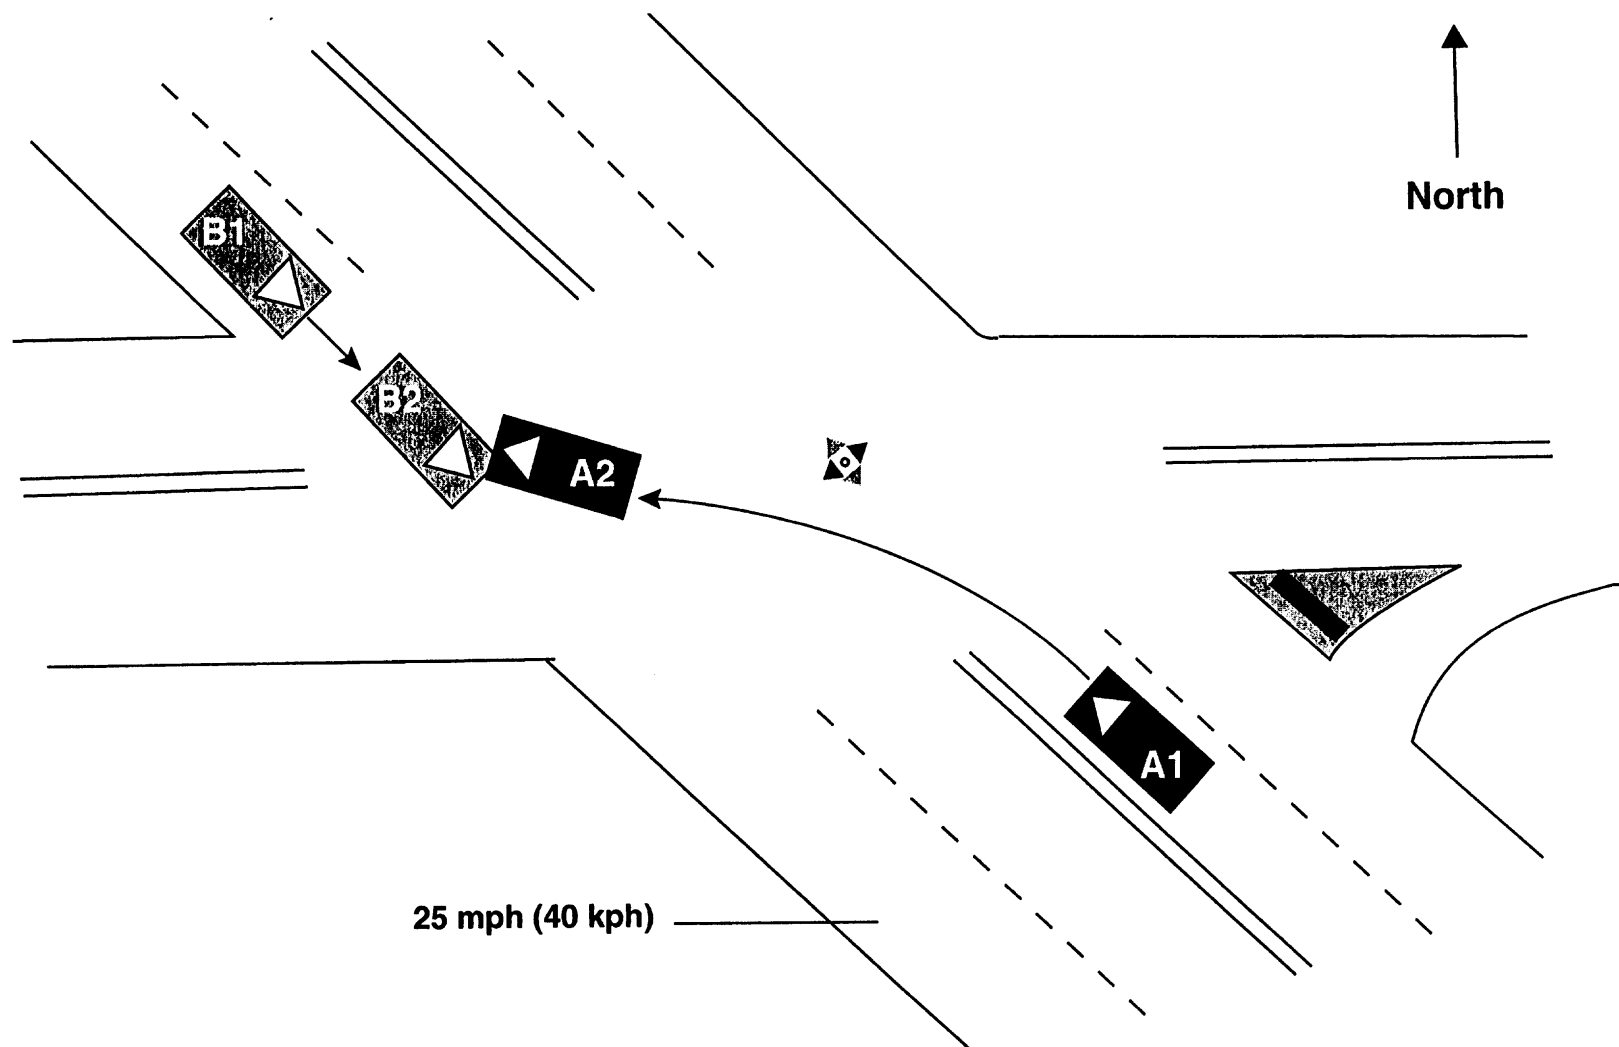
ACCIDENT SCHEMATIC

ACCIDENT DESCRIPTION: CASE VEHICLE (A) WAS TRAVELING IN A NORTHWEST DIRECTION AT AN UNKNOWN SPEED. VEHICLE (B) WAS TRAVELING IN A SOUTHEAST DIRECTION IN THE RIGHT LANE. AS PROCEEDING THROUGH THE INTERSECTION, CASE LEFT TURN TO TRAVEL WEST. THE FRONT OF STRUCK THE LEFT FRONT OF VEHICLE (B).

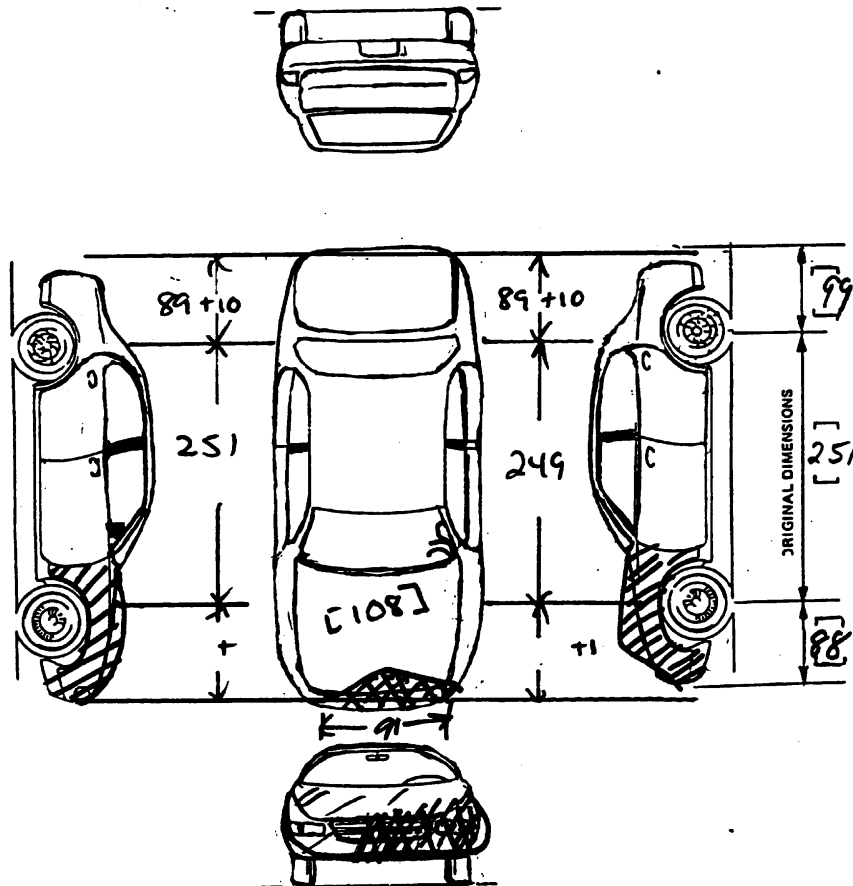
VEHICLE DAMAGE

Direct Damage Length (DDL) 091 cm
35 37

Specific Impact No.	Location of Direct Damage	Location of Field L
1	BEGINS AT LEFT-FRONT BUMPER CORNER 91-cm	BUMPER CORNER TO BUMPER CORNER

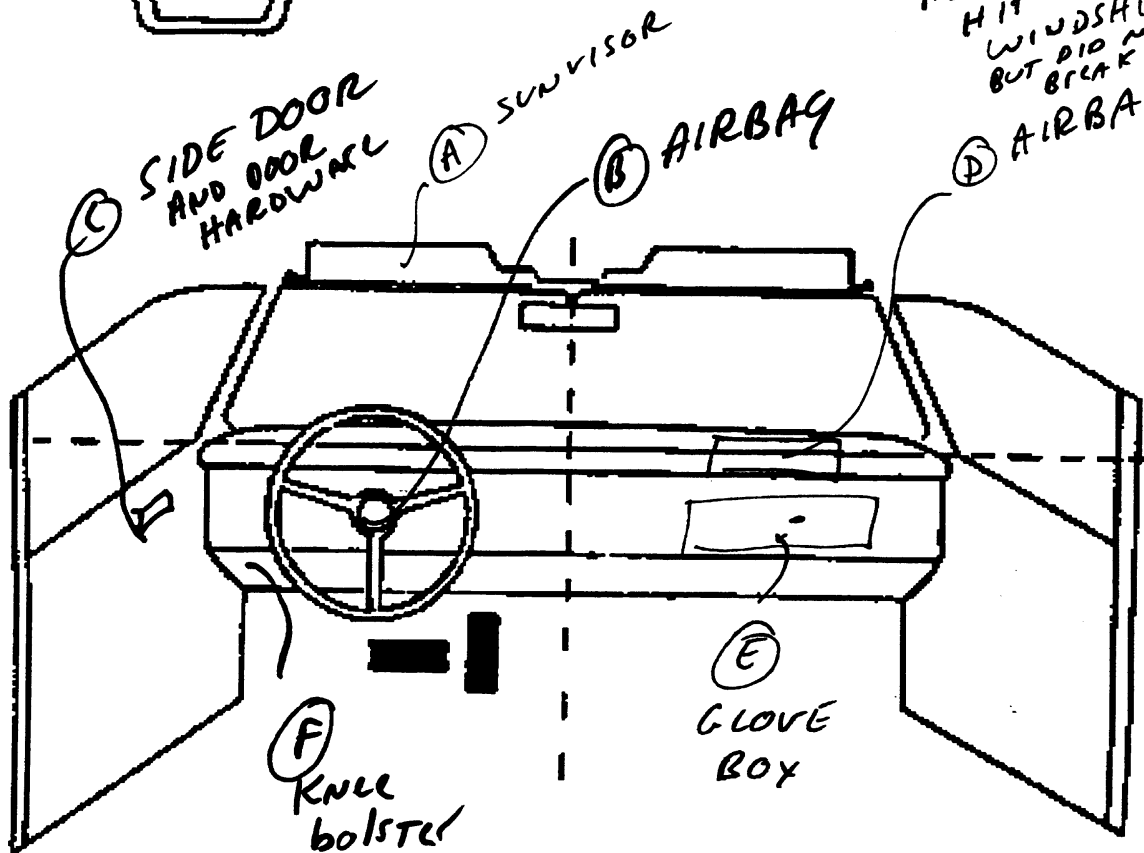
VEHICLE OCCUPANT CONTACT DIAGRAM

Contact	Interior Component Contacted	Occupant No. if Known	Body Region if Known	Supporting Physical Evidence	Confidence Level of Contact Point
A	SUNVISOR	1		3-CM BLACK MARK	2
B	AIRBAG	1	LIPS	LIPSTICK	/
C	SIDE DOOR AND HANDLE	1	ARM	9YH SCUFF	/
D	AIRBAG	2	FACE	MAKEUP	/
E	FLOOR BOX	2	KNEE	5-CM SCUFF	/
F	KNIE BOLSTER	1	KNIE	SCUFF	
G					
H					
I					
J

DR BELT: TIGHT IN RETRACTOR
MID ON B-PILLAR

RF BELT: TIGHT IN RETRACTOR
UP ON B-PILLAR
AB COVER

HIT
WINDSHIELD
BUT DID NOT
BREAK GLASS

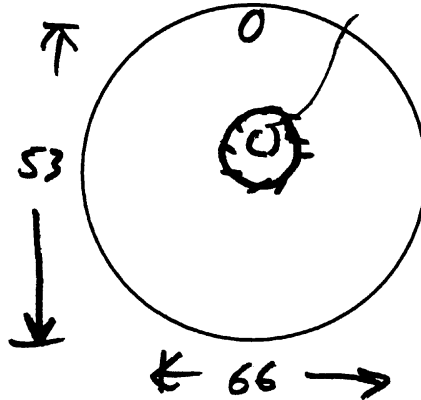
1 VENT
AT 12:00

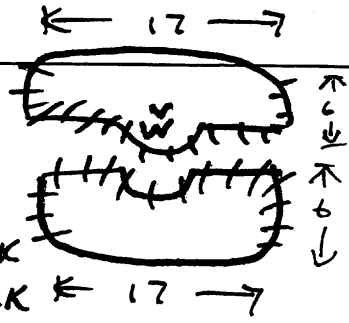
LIPSTICK
MARK

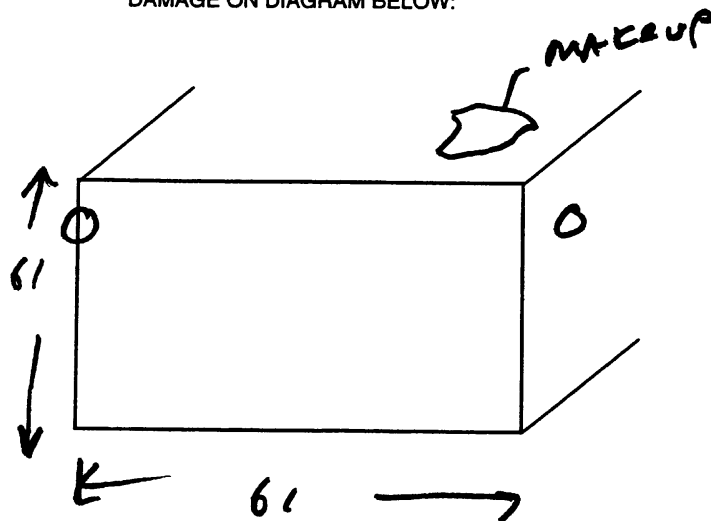
TWO
VENTS
ON
SIDE

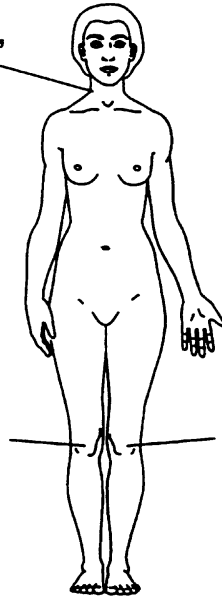
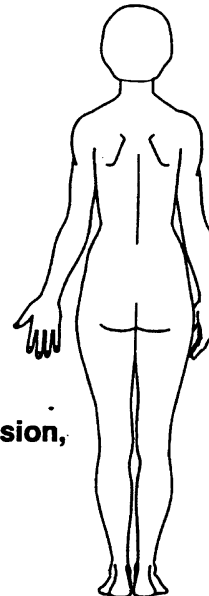
INDICATE LOCATION OF INJURIES.

Contusion and abrasion,
right anterior neck
(1)

Contusion, right knee
(1)

Contusion and abrasion,
left knee
(1)
